## Prüfbericht Test Certificate

<b>Prüfgegenstand // Object:</b>	Measurement of temperature behaviour of All Sky Imager ASI-16.
<b>Auftraggeber // Customer:</b>	CMS Ing. Dr. Schreder GmbH Lofererstraße 32, A-6322 Kirnbichl AUSTRIA
<b>Hersteller // Manufacturer:</b>	CMS Ing. Dr. Schreder GmbH
<b>Typ // Type:</b>	ASI-16
<b>Seriennummer // Serial number:</b>	16015
<b>Datum // Date:</b>	13. June 2016 - 15. June 2016
<b>Seitenanzahl // Number of pages:</b>	3

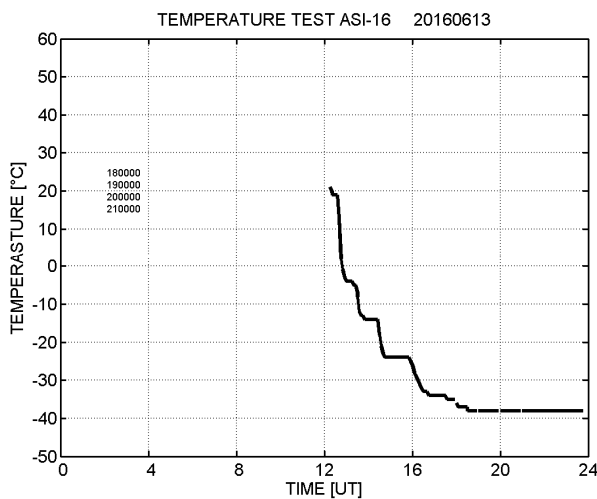
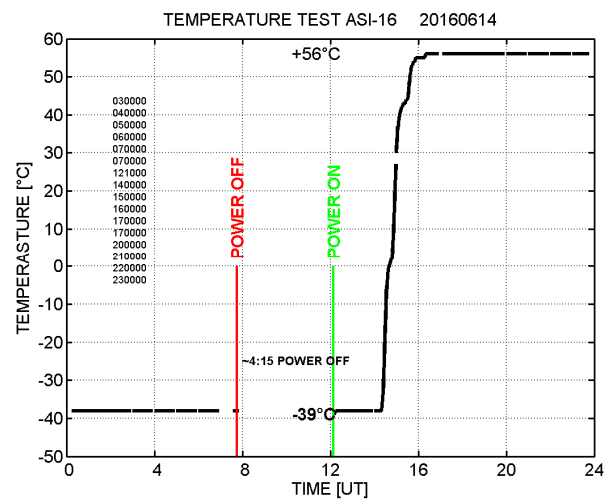
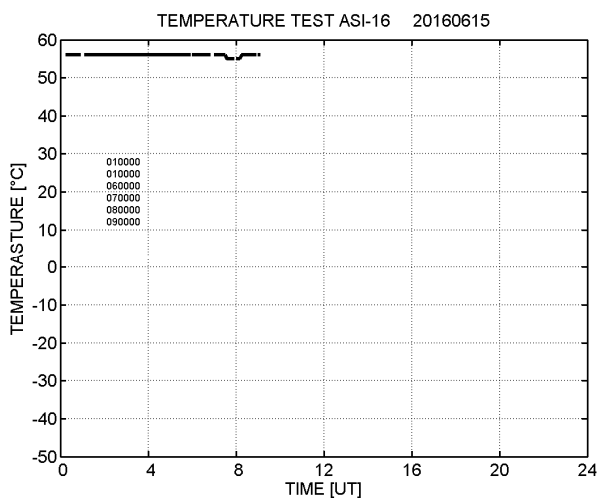
The All Sky Imager was successfully tested for standard operation modus under "Extended Temperature Range" between -40°C to +56°C, with a measurement and climate chamber control tolerance of  $\pm 3$  °C. Restart of the ASI was carried out with deactivated internal heating system at lowest environmental temperature. The system was running under all tested environmental situations without troubles. The temperature measurements are presented in the plots below.

Temperatures were logged with the ASI internal temperature sensor and an external temperature sensor ( $T_{EXT}$ ). The  $T_{EXT}$  was put in a distance of about 8cm above the glass dome of the ASI. The  $T_{EXT}$  showed a temperature which was about +6 °C higher than the ASI temperature sensor. This temperature difference is the effect of the internal heating system of the ASI.

On day 20160613 the device under test was running under standard operation modus. Environmental temperature  $T_{ENV}$  was set at levels +21°C, +16°C, -10°C, -30°C, -40°C. The internal heating system of the device under test was running (electrical heating with about 60W). At 18:00 ( $T_{ENV}$  = -30°C) the heating system was switched off (not standard operation) to test the coldest environmental situation. ASI was running as required.

On day 20160614 the device under test was running under not standard operation modus (the internal heating system of the ASI was switched off). The internal heating system of the device under test was switched off. The  $T_{ENV}$  was set to -40°C since day 20160613. At 08:00 the power of the system was switched off to test the restart behaviour. After 4 hours at 12:00 power was switched on again. The ASI started and was working as required. At 16:15 the environmental temperature was set to +56°C. In

On day 20160615 the device under test was running under not standard operation modus (the internal heating system of the ASI was switched off). The environmental temperature was set to +56°C since day 20160615. ASI was running as required.
